**DRAFT FINAL
INTERIM REMEDIAL MEASURES
WORK PLAN
EKCO HOUSEWARES FACILITY
MASSILLON, OHIO**

December 1993

ROY F. WESTON, INC.
1 Weston Way
West Chester, Pennsylvania 19380

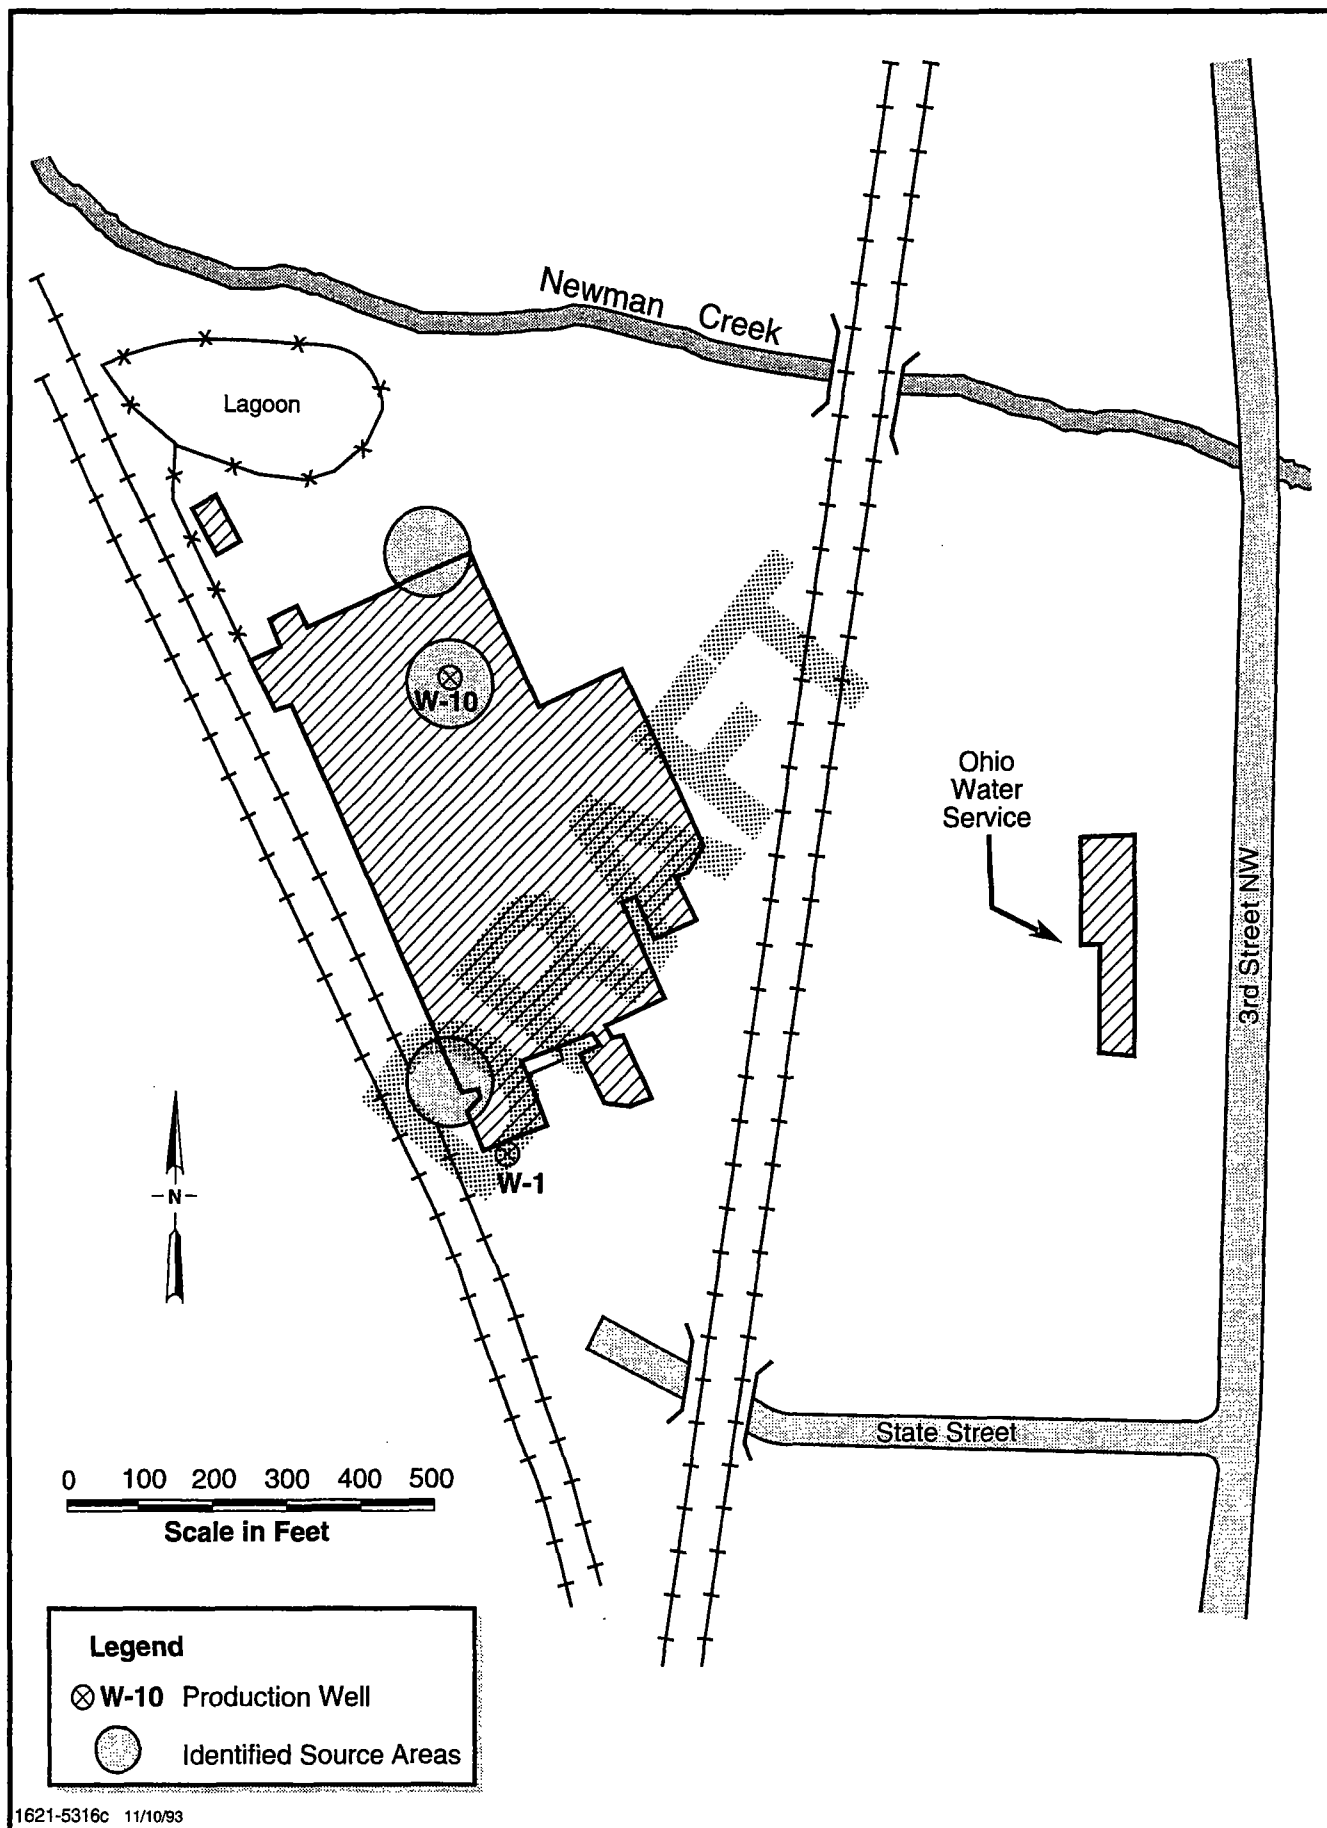
FIGURE 2-1 VOC SOURCE AREAS IDENTIFIED DURING THE RFI

Based on soil borings advanced in 1988 and 1991, the following three VOC source areas were identified (see Figure 2-1):

- Tank area at southwestern end of plant.
- Sump at production well W-10.
- Tank area at northern end of plant.

TCE was the primary constituent detected at the tank area at the southwestern end of the plant. TCE contamination was detected at concentrations of 140 ppm and 2 ppm in two of the borings drilled in this area. In the tank area at the northern end of the building, TCE and dichloroethene (DCE) were the primary constituents detected. TCE was detected at all depth intervals in borings installed at the northern end of the building. DCE was detected at 34 ppm in one boring installed through the floor of the building adjacent to the sump at well W-10.

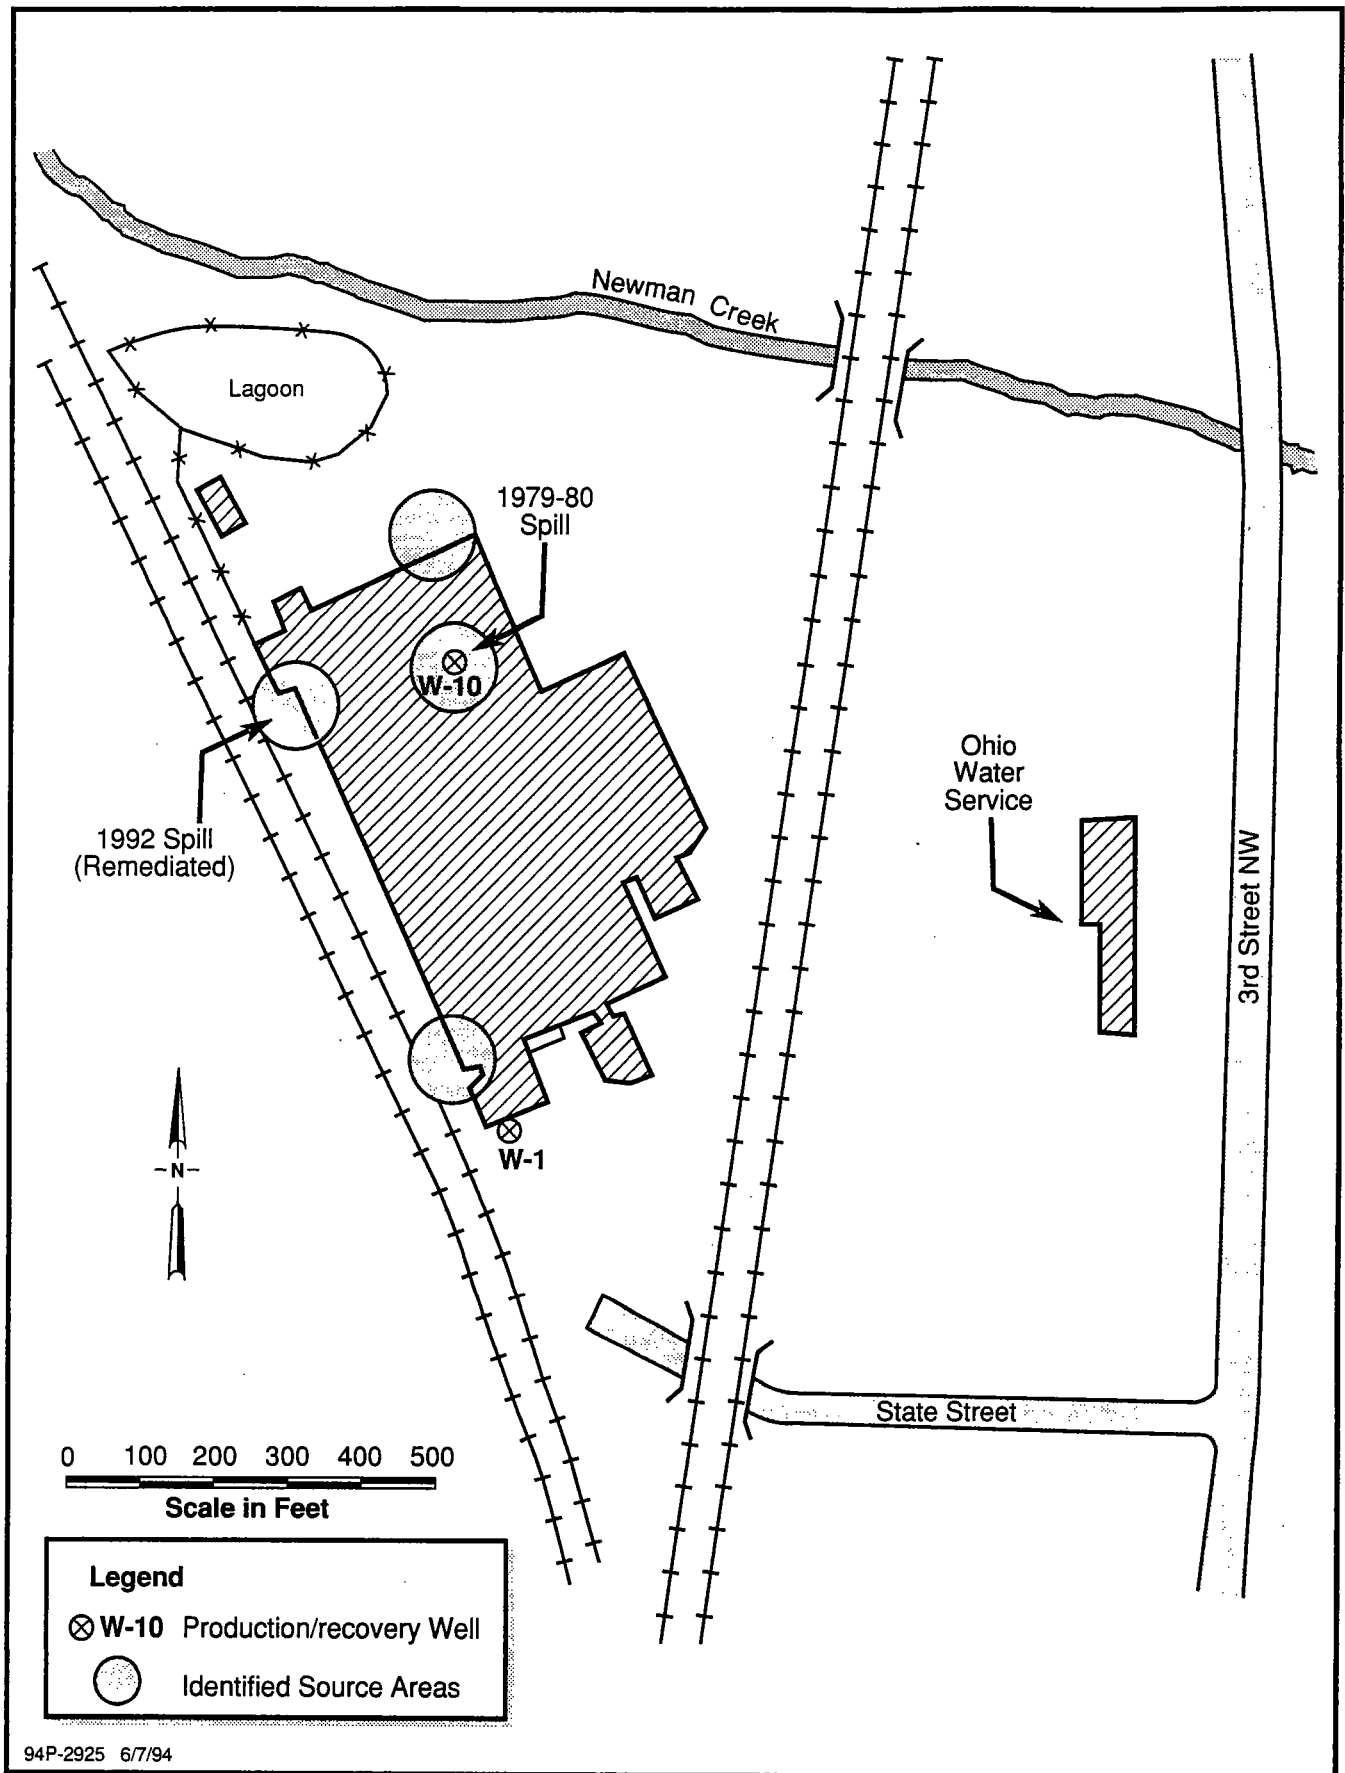
FIGURE 1-3 THE LOCATIONS OF DOCUMENTED SPILLS AND VOC SOURCE AREAS IDENTIFIED DURING THE RFI EKCO HOUSEWARES FACILITY – MASSILLON, OHIO

Correspondence between EKCO and the Ohio Environmental Protection Agency (OEPA) identified a solvent spill that occurred between 1979 and 1980 as the first major recorded spill at the facility. The spill was reported to have occurred in the vicinity of plant production well W-10, (Figure 1-3), but the extent of the spill was not documented.

In 1992, EKCO reported to the U.S. EPA Region V, a 330-gallon spill of 1,1,1-TCA on the western side of the building (Figure 1-3). Some TCA entered a nearby storm sewer and reached the outfall at Newman Creek. TCA was recovered from the storm sewer using a vacuum truck. The portion of the sewer where the spill entered was blocked, and an underwater weir was constructed at the sewer outfall and an activated carbon filter was placed on the upstream side of the weir to adsorb product. Fifty tons of soil were excavated from the spill location in the presence of an OEPA representative. The soil was containerized and transported to the Envirosafe Services of Ohio, Inc. hazardous waste landfill in Toledo, Ohio.

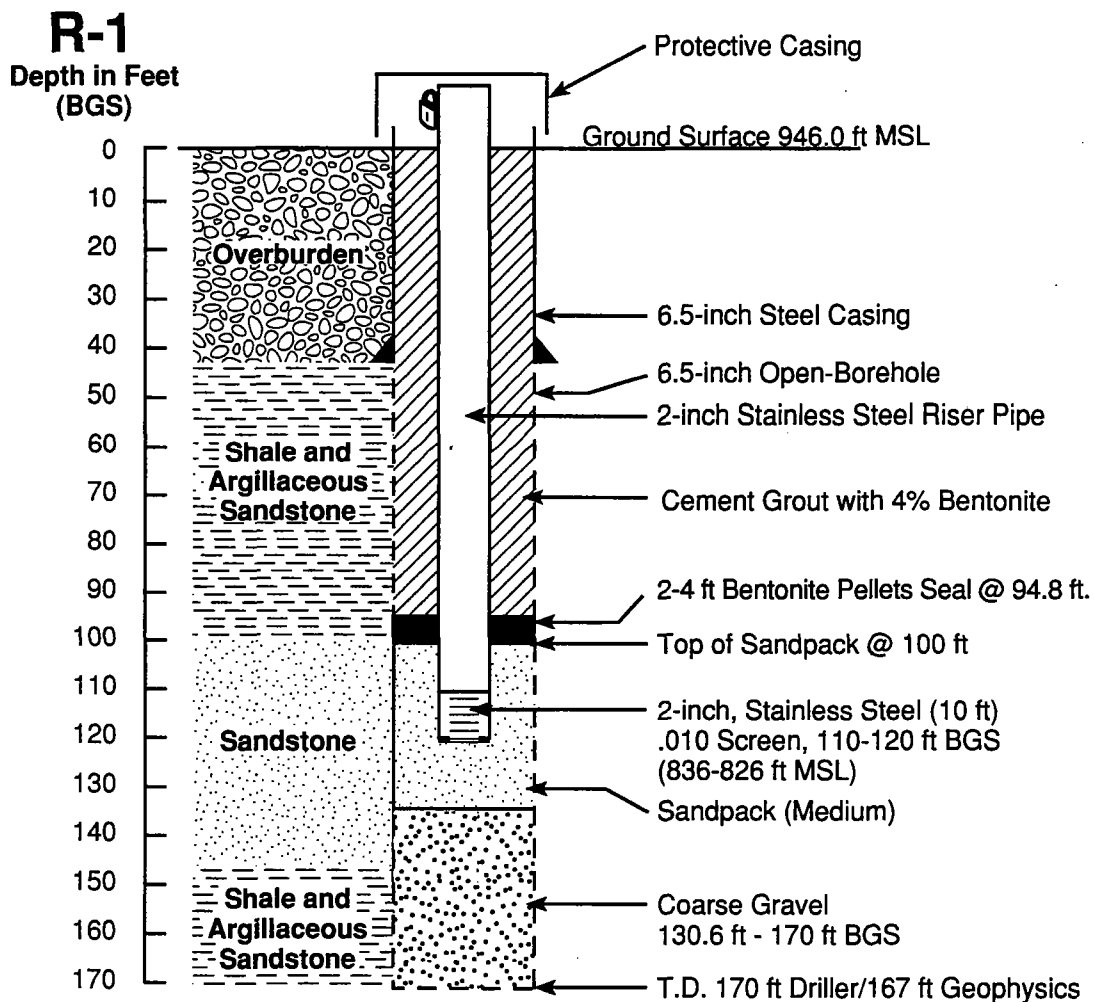
**FIGURE 2-1 SCHEMATIC OF RETROFITTED WELL R-1,
EKCO HOUSEWARES, MASSILLON, OHIO**

- Well R-1 required 162 gallons of grout, pumped in 2 stages, compared to the theoretical volume of 116 gallons.

Casing Stickup: 0.9 ft
Drilling Method: Rotary
Date Drilled: 25 October 1984
6.5-in Casing set @ 42 ft BGS
Top of Bedrock @ 41 ft BGS

Installation of the 2-inch diameter screen (10 foot length in each well) and riser, involved suspending the well materials in tension until sandpacking of the screen and grouting of the riser was completed. Holding the well in tension in this manner insured a plumbed well. Additionally, 2 stainless steel centralizers were attached to the well and set at a diameter of 5-inches. Each well was sandpacked with Sidley 1020 sand (medium-grained) from the top of the gravel backfill to approximately 10 feet above the top of the 2-inch well screen. Once the sandpack was in place and fully settled, a 1-2 foot thick bentonite seal was emplaced above the sandpack and allowed to hydrate overnight. The wells were subsequently tremie grouted from the top of the bentonite seal to ground surface. As with the grouting of the W-wells liners, the grouting of the R-wells was performed in a staged manner to minimize formation loss and to assess the magnitude of grout loss behind the steel casings. A 4% cement/bentonite slurry was also used in the sealing of the R-wells between the 2-inch risers and the 6-inch borehole and steel casing. After a minimum curing period of 24 hours for the 1st stage of grout, each R-well was developed and purged of 3 to 5 well volumes using a low-flow submersible pump. Schematic representations of each retrofitted R-well are provided in Figures 2-1 through 2-3.

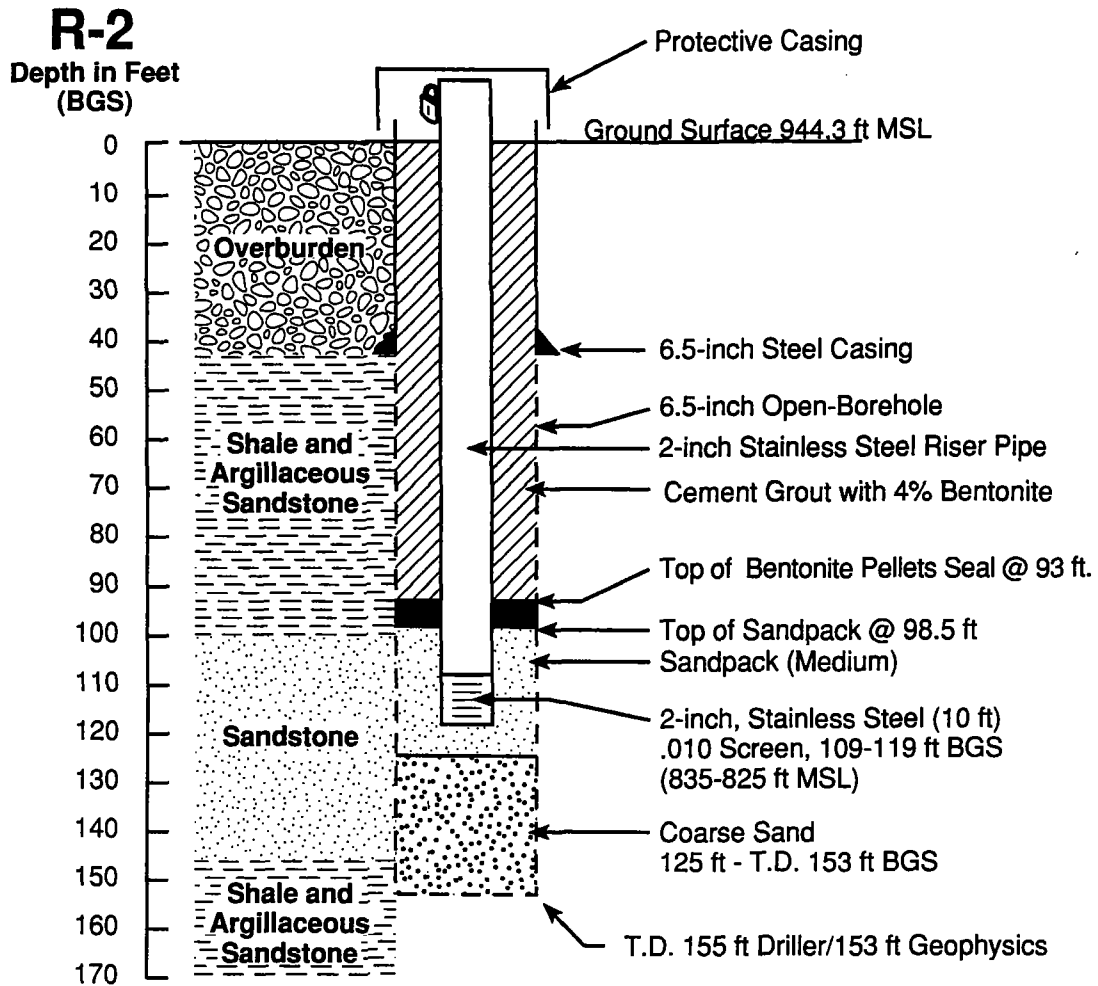
**FIGURE 2-2 SCHEMATIC OF RETROFITTED WELL R-2,
EKCO HOUSEWARES, MASSILLON, OHIO**

Casing Stickup: 2.2 ft
Drilling Method: Rotary
Date Drilled: 29 October 1984
6.5-in Casing set @ 46 ft BGS
Top of Bedrock @ 44 ft BGS

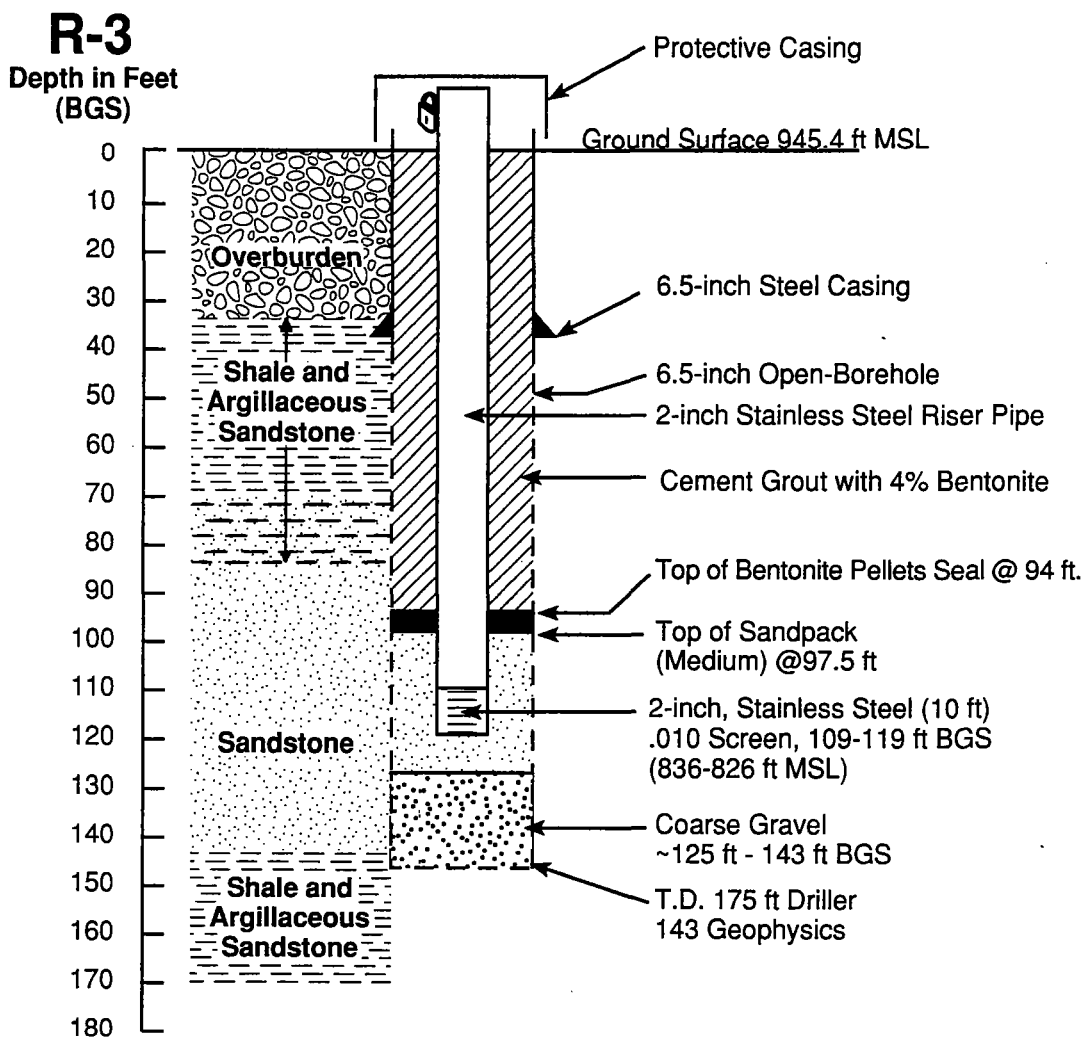
**FIGURE 2-3 SCHEMATIC OF RETROFITTED WELL R-3,
EKCO HOUSEWARES, MASSILLON, OHIO**

Casing Stickup: 1.74 ft
Drilling Method: Rotary
Date Drilled: 30 October 1984
6.5-in Casing Set @ 37 ft BGS
Top of Bedrock @ 32 ft BGS

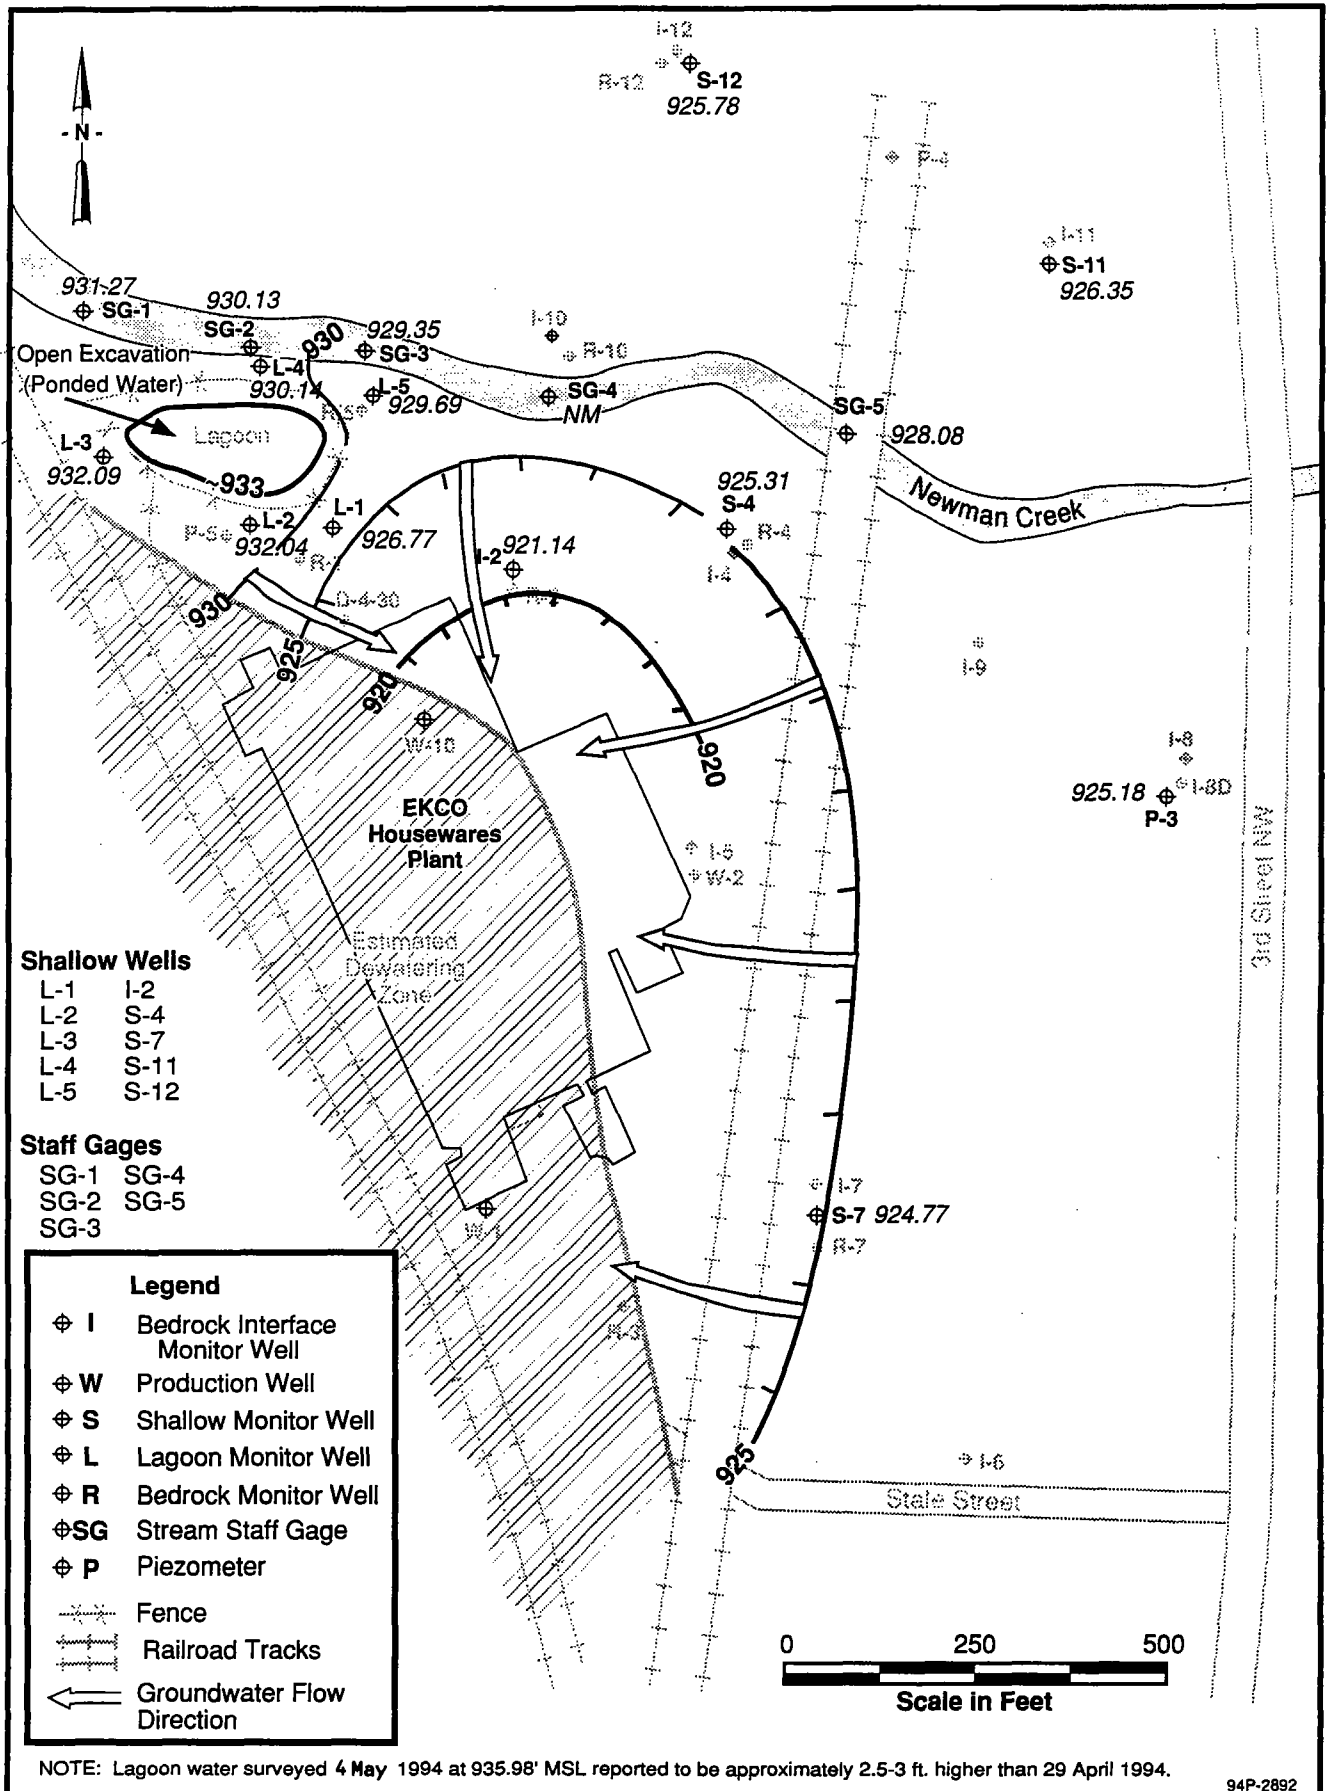
FIGURE 3-1 GROUNDWATER CONTOUR MAP OF WELLS COMPLETED IN THE SHALLOW SAND AND GRAVEL WATER BEARING ZONE – 29 APRIL 1994 EKCO HOUSEWARE FACILITY – MASSILLON, OHIO

The groundwater contour map for the shallow sand and gravel indicates that the groundwater flow direction in this unit continues to be towards site recovery wells W-1 and W-10 (Figure 3-1). In the northern portion of the site, the calculated horizontal hydraulic gradients ranged from 0.022 to 0.030 ft/ft. A portion of the hydraulic gradient in this northern area of the site may be attributable to natural gradients flowing away from Neuman Creek both to the north and south. Comparison of staff gage measurements in the creek to shallow wells in this area suggests the creek may be a losing stream. In the southern portion of the site the calculated horizontal hydraulic gradient was approximately 0.039 ft/ft. In this southern portion of the site, the shallow groundwater gradients appear to be influenced by the pumping of the on-site recovery wells as the erosional bedrock surface subcrops in contact with the shallow overburden units in the area of the southern site boundary (see cross-section B-B, Figure 1-5).

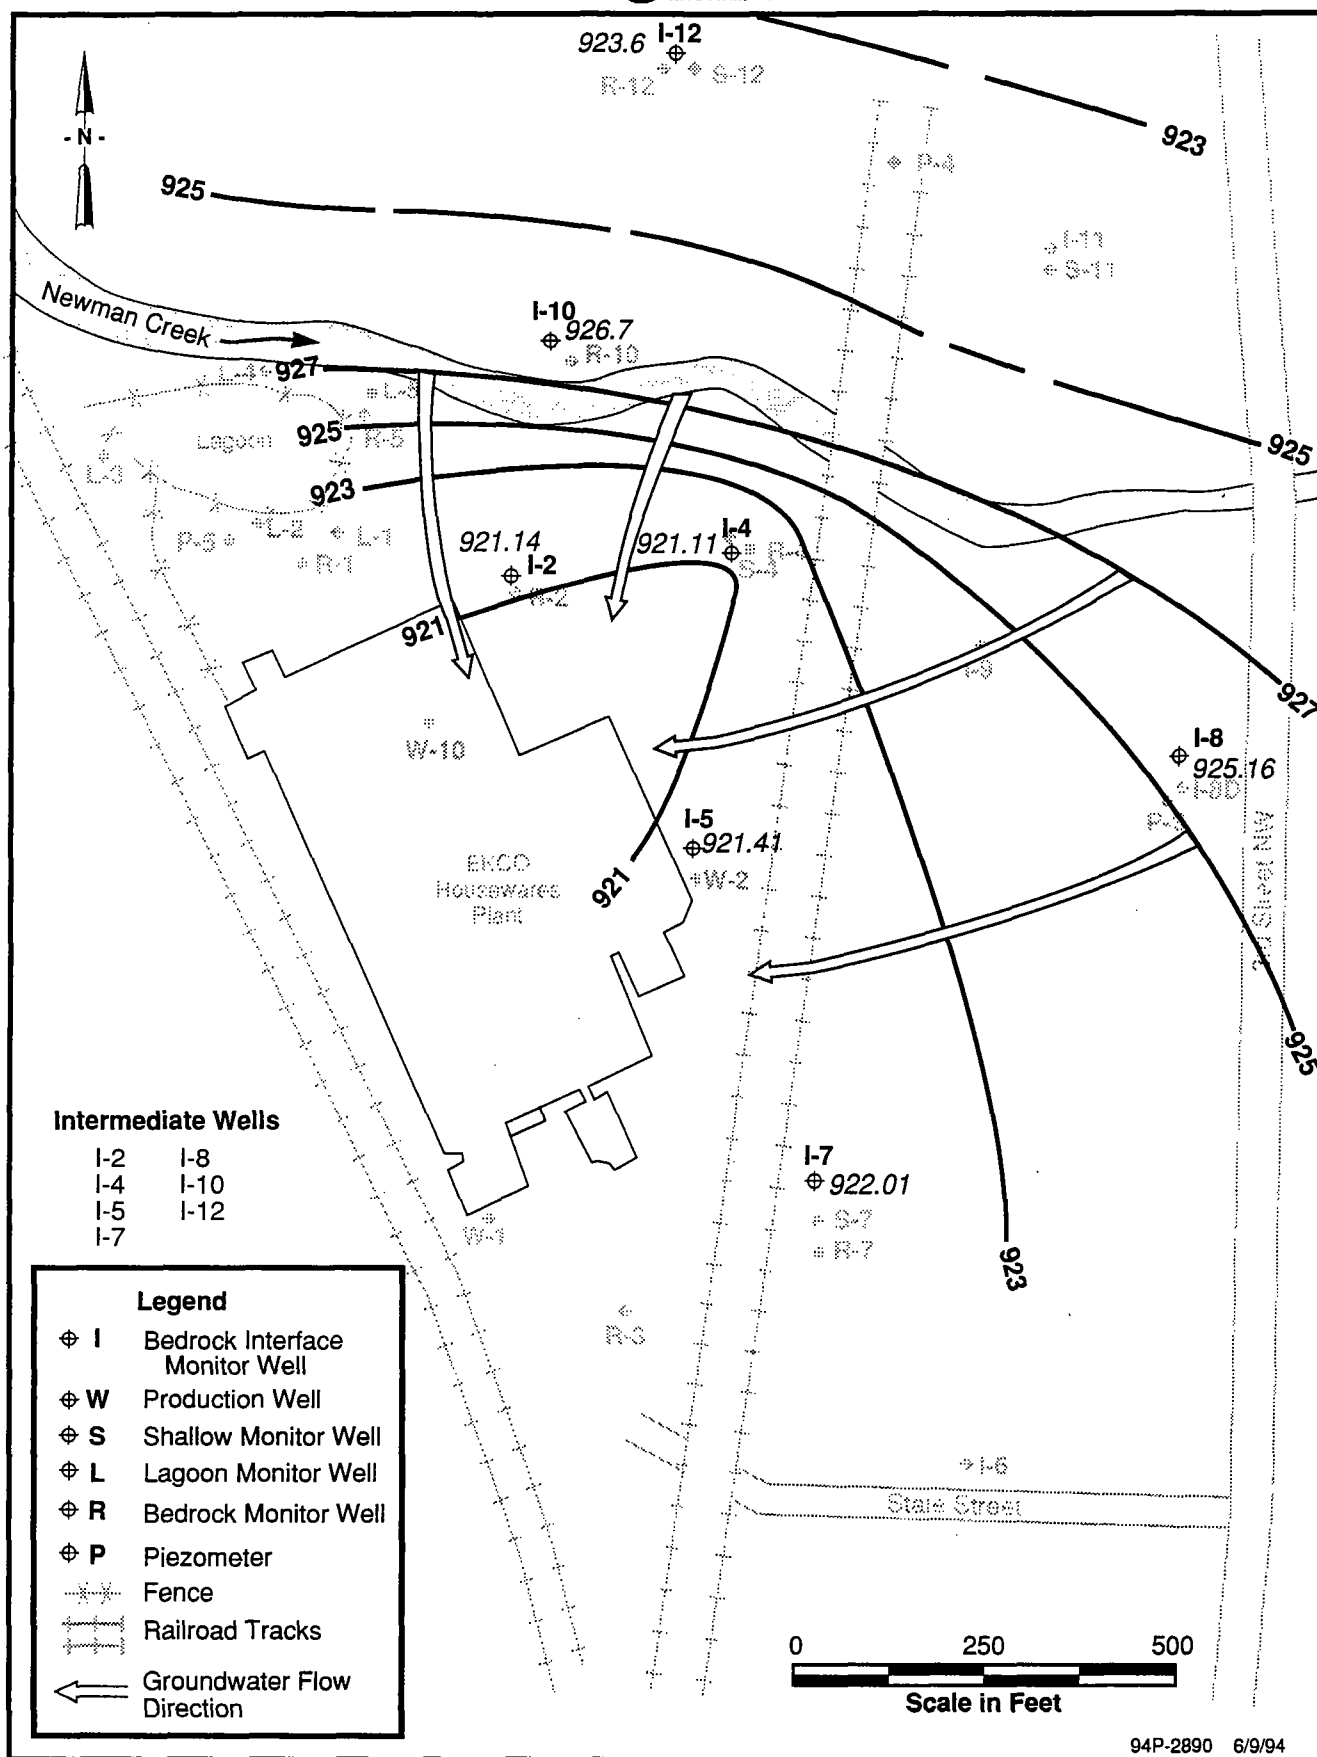
**FIGURE 3-2 GROUNDWATER CONTOUR MAP OF WELLS COMPLETED IN THE INTERMEDIATE SAND AND GRAVEL WATER BEARING ZONE, WATER LEVELS MEASURED 29 APRIL 1994
EKCO FACILITY – MASSILLON, OHIO**

The groundwater contour map for the intermediate sand and gravel indicates that the groundwater flow direction in this unit continues to be towards site recovery wells W-1 and W-10 (Figure 3-2). In the northern portion of the site, the calculated horizontal hydraulic gradient was approximately 0.021 ft/ft. In the southeastern portion of the site, the calculated horizontal hydraulic gradient was approximately 0.005 ft/ft.

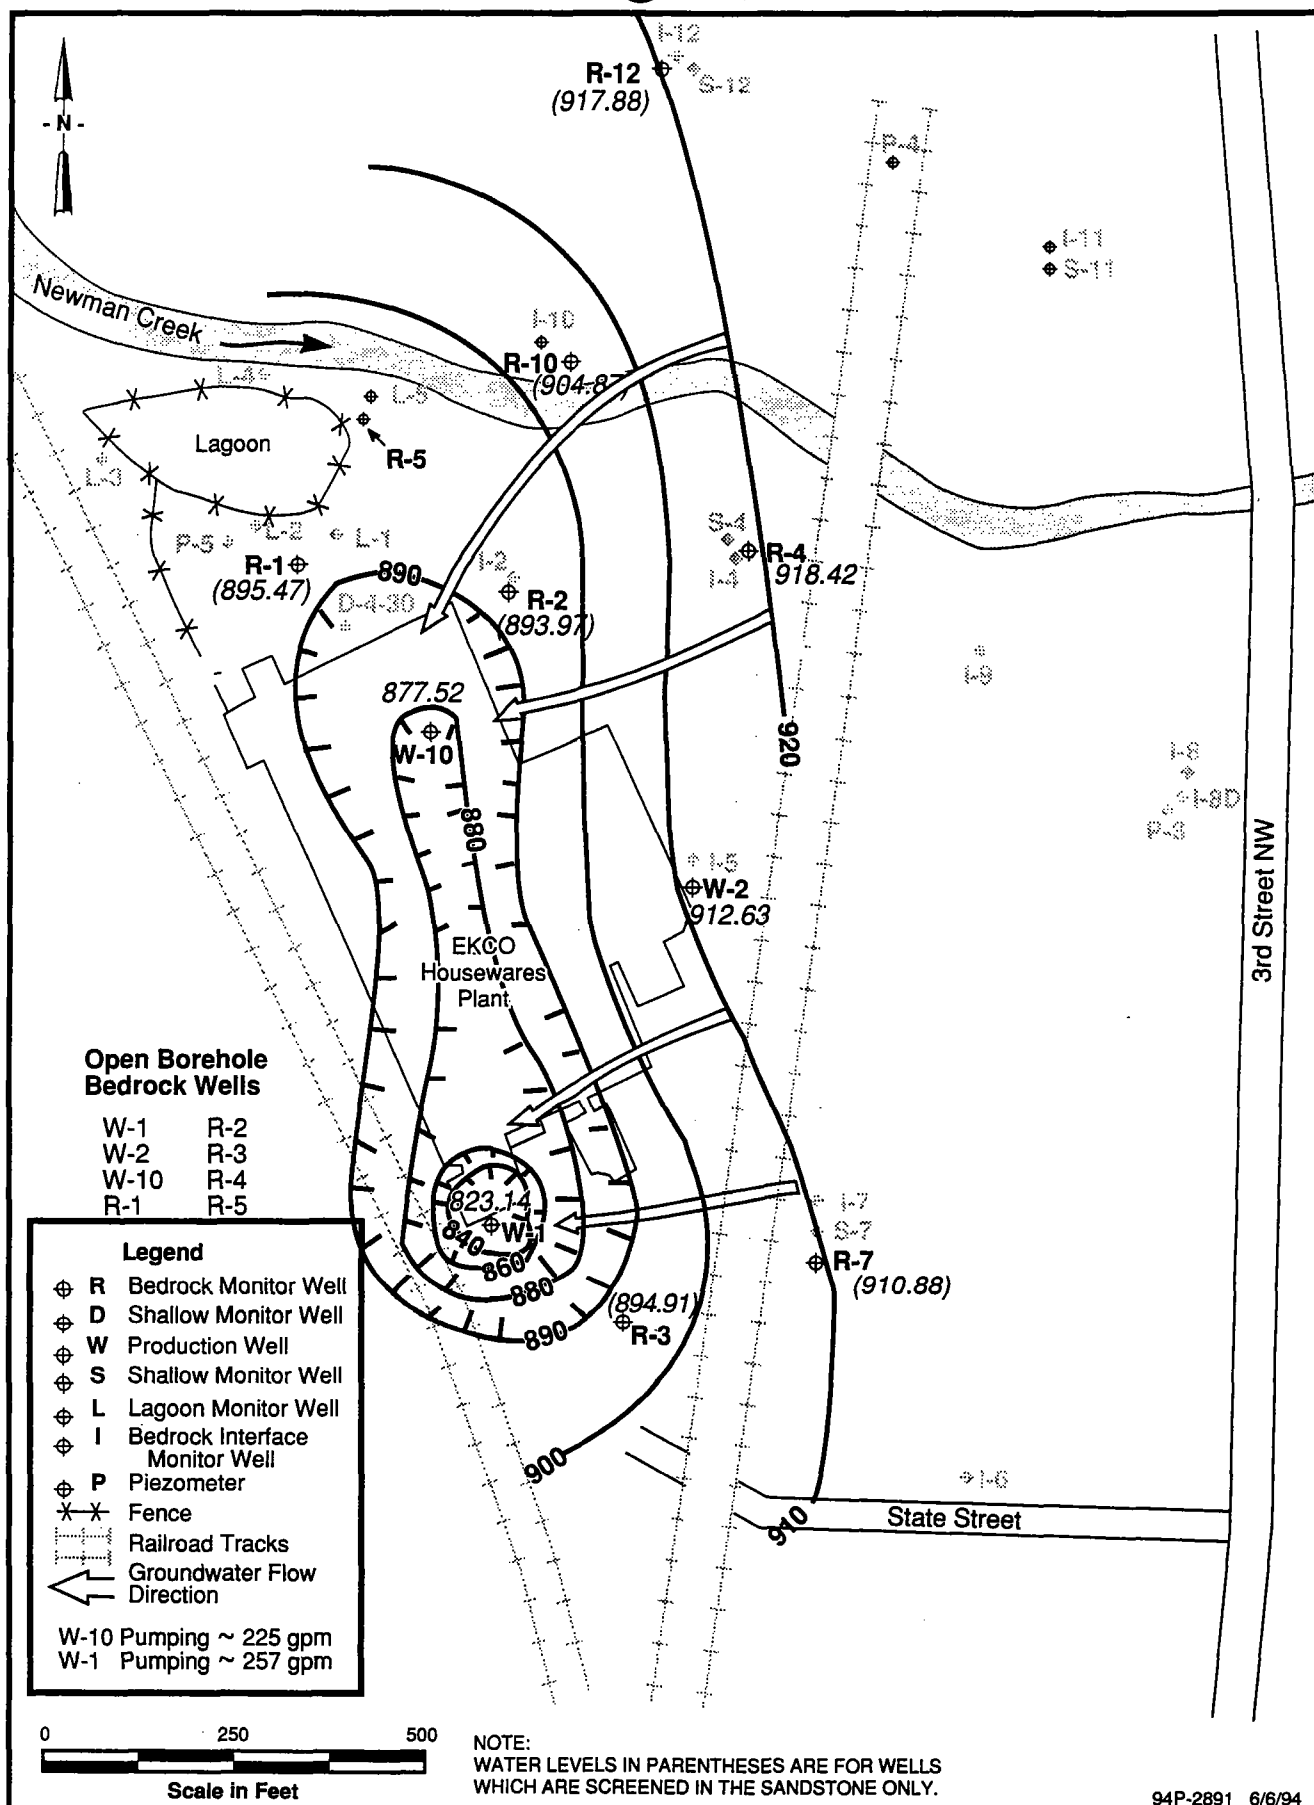
**FIGURE 3-3 GROUNDWATER CONTOUR MAP OF WELLS COMPLETED IN THE BEDROCK, 29 APRIL 1994
EKCO HOUSEWARES FACILITY – MASILLON, OHIO**

The groundwater contour map for the bedrock indicates that the groundwater flow direction in this unit continues to be towards site recovery wells W-1 and W-10 (Figure 3-3). In the northern portion of the site, the calculated horizontal hydraulic gradients ranged from 0.10 to 0.08 ft/ft towards recovery well W-10. In the southern portion of the site the calculated horizontal hydraulic gradients were greater, ranging from 0.20 to 0.35 ft/ft towards recovery well W-1. The addition of water level drop-pipes (stillwells) in the recovery wells during liner installations made the collection of accurate pumping water levels more feasible than in the past, (especially in well W-1). As shown in Figure 3-3, a large composite cone of depression exists on the potentiometric groundwater surface of the bedrock unit as a result of the combined pumping of wells W-1 and W-10 (257 gpm and 225 gpm respectively).

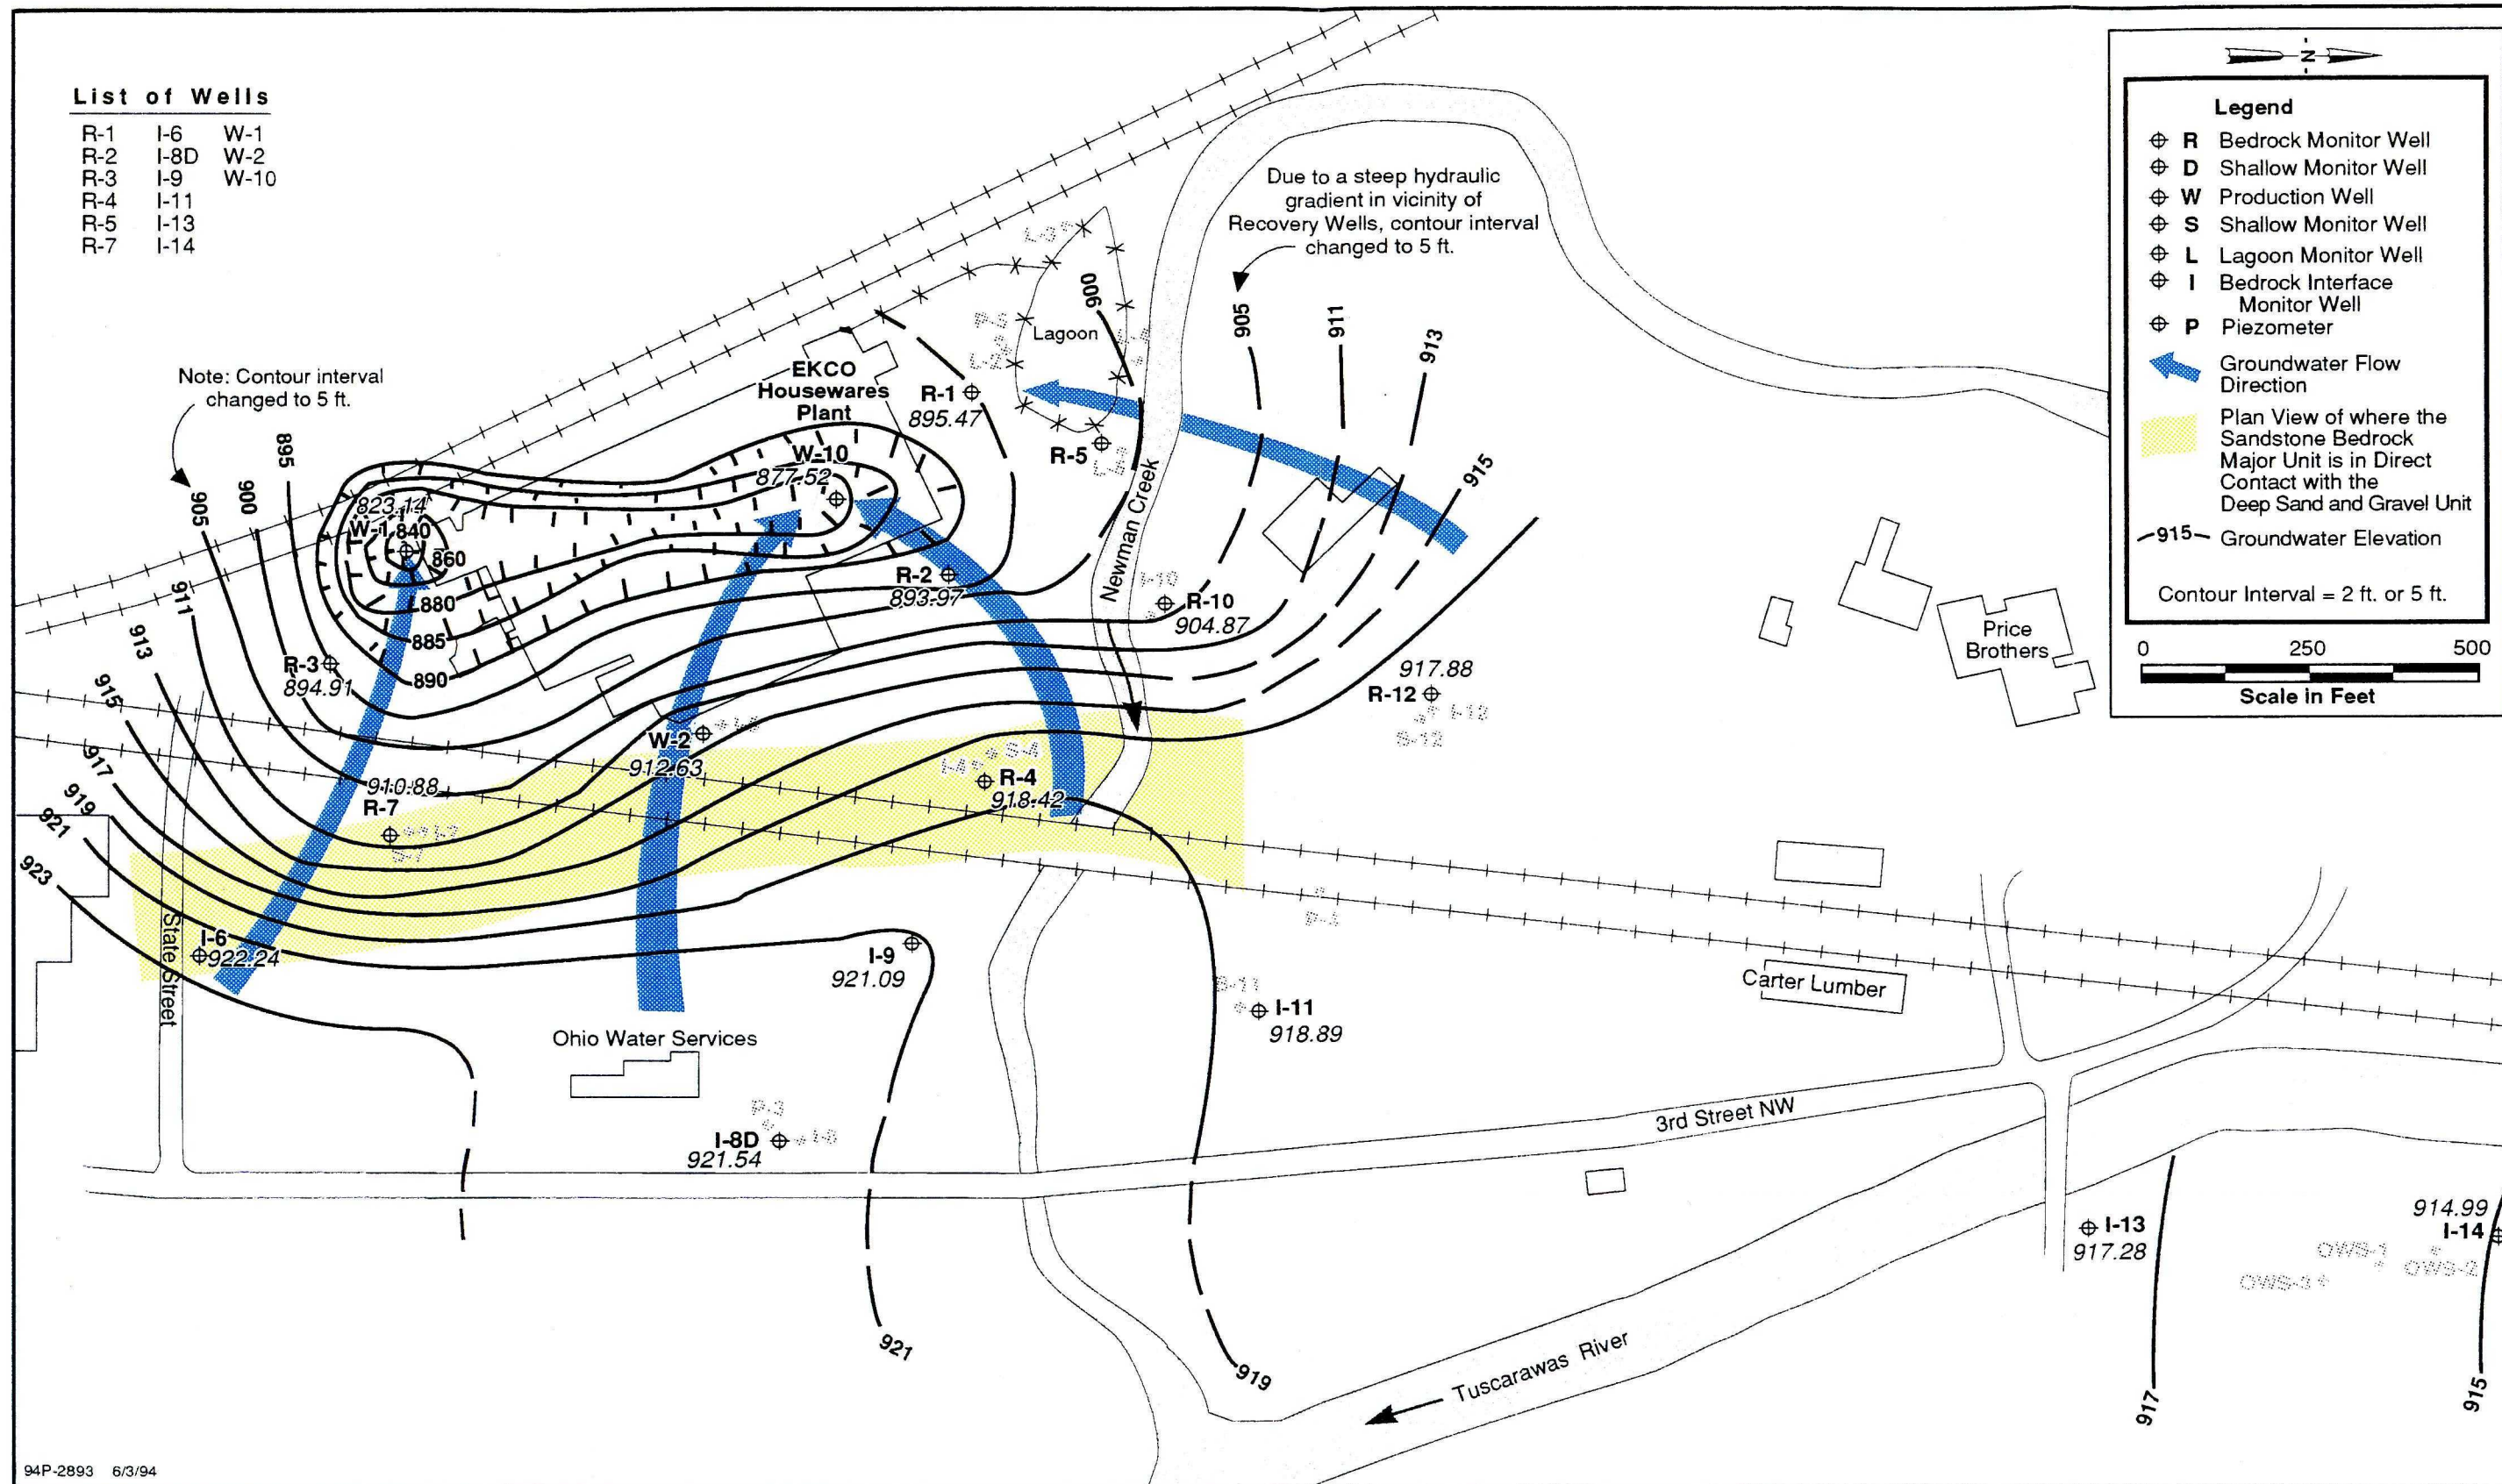
FIGURE 3-4 GROUNDWATER CONTOUR MAP OF WELLS COMPLETED IN THE DEEP SAND AND GRAVEL AND BEDROCK WATER BEARING ZONE-29 APRIL 1994 EKCO FACILITY, MASSILLON, OHIO

The groundwater contour map for the deep sand and gravel indicates that in the areas near the sandstone/deep unit contact, groundwater continues to flow west towards the EKCO site as a result of the pumping of recovery wells W-1 and W-10 (Figure 3-4). Farther away from the site, near wells I-11 and I-13, groundwater flow in the deep sand and gravel unit continues to be governed by the OWS wells which pull groundwater to the north. The calculated horizontal hydraulic gradients towards the site ranged from 0.05 ft/ft in the vicinity of well I-6, to 0.015 ft/ft in the vicinity of well I-9.
